CHCCS Facilities Assessment Recommendations

CHCCS Facilities Assessment

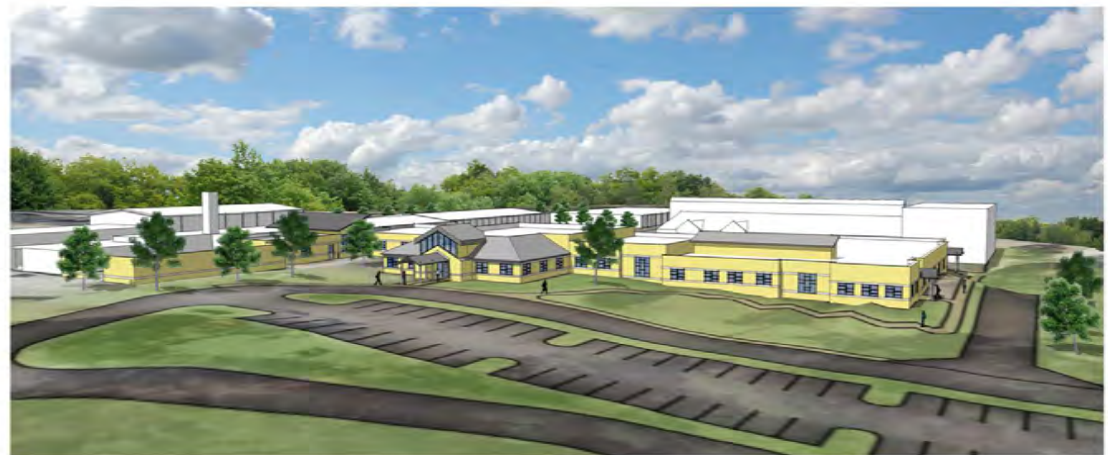
CARRBORO ELEMENTARY SCHOOL

- One mobile unit on-site
- 100 classroom wing has dead-end corridors and does not meet the current NC State Building Code
- Administration area, cafeteria, kitchen and staff support spaces are too small
- Program deficiencies - art room and 5 smaller classroom spaces
- Existing queueing for parent drop-off occurs on Shelton Street
- Stacking traffic onto the public right of way is a safety concern
- Aging mechanical system
- Campus-style layout lacking connection from main building to the multipurpose building
- Modular walls between classrooms causing noise transfer between classrooms

Construction: Precast concrete frame with brick infill and built-up roof

- Eliminates life safety issues in Building 100 by deconstruction and building new academic wing
- Provide a new administration suite main entrance
- Moves queuing off of the road
- Connects all existing building internally
- Renovate all existing buildings
- Increase capacity by 52 seats.

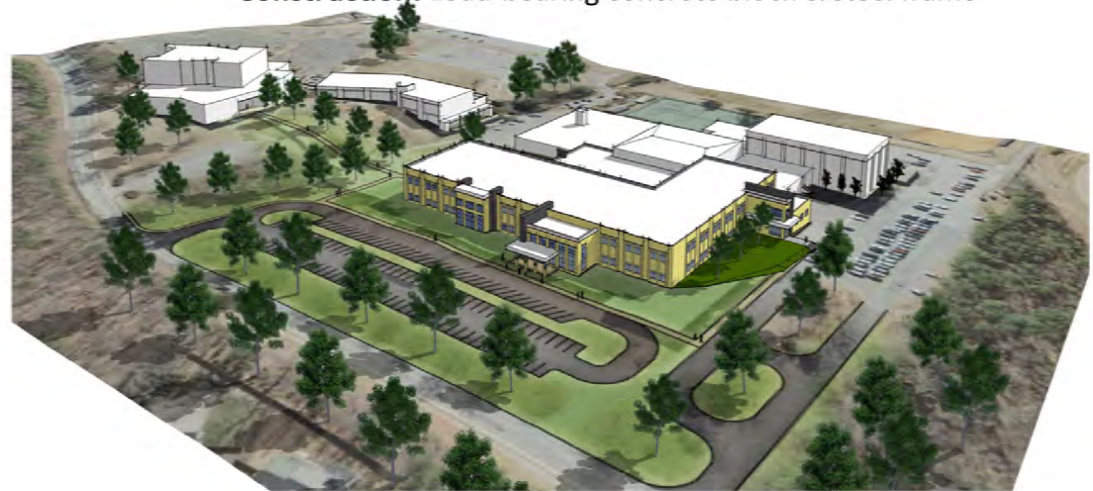
CHAPEL HILL HIGH SCHOOL

- Deteriorated facility conditions
- Building "A" houses most of the classrooms and science rooms that are smaller than the School Construction Standards
- Fourteen mobile units on-site housing 9 academic classrooms, Ridge, 2 Blue Ribbon classrooms, & 2 health classrooms
- Drama, dance, wrestling, & weight rooms are significantly undersized
- Staff support space is undersized and inefficiently configured
- Campus-style layout lacking connection between the four buildings
- Major site drainage issues
- Main entrance is not ADA accessible
- Ramp between Main Building "A" and A2 does not meet Code
- Aging mechanical systems causing humidity issues

Construction: Load-bearing concrete block & steel frame

- Deconstruct Building A and construct an addition to house the current program spaces as well as the deficient program spaces
- Create a new accessible and secure main entry for students, staff and visitors.
- Address the oldest building on the high school campus and the major mechanical issues.
- Connects more of the campus internally
- Renovate all existing buildings
- Eliminate mobiles on site

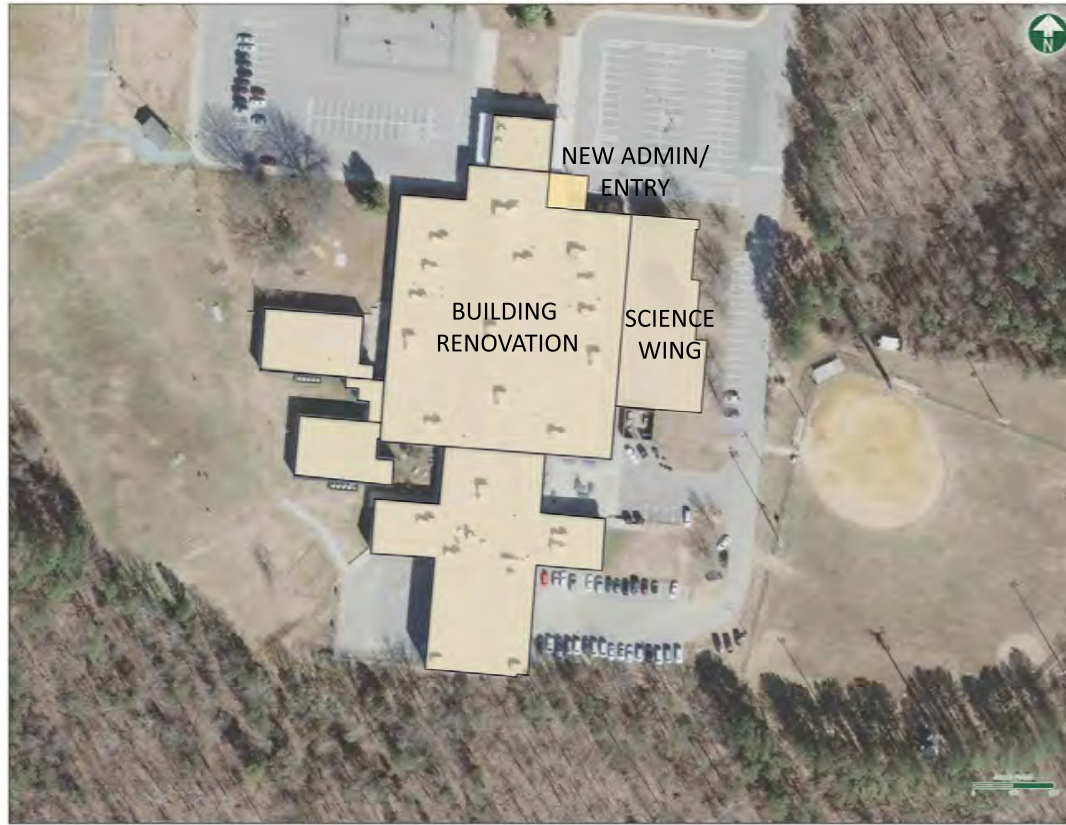
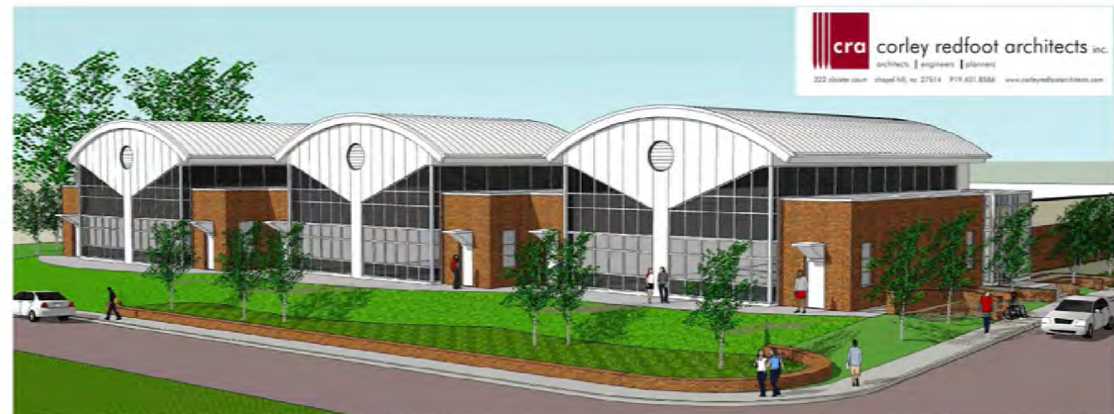
CULBRETH MIDDLE SCHOOL

- Operating slightly over capacity
- No mobile units
- Six science classroom addition under construction
- Additional staff support space needed
- Location of administration suite presents security concerns
- Modular partition walls between classrooms allow sound transfer between classes
- Water infiltration issues into the lower level Band room
- Major damage to EIFS on exterior of building

Construction: Load-bearing CMU wall construction

- Renovate existing building.
- Construct small addition that provides new location for administration suite and provides secure main entrance

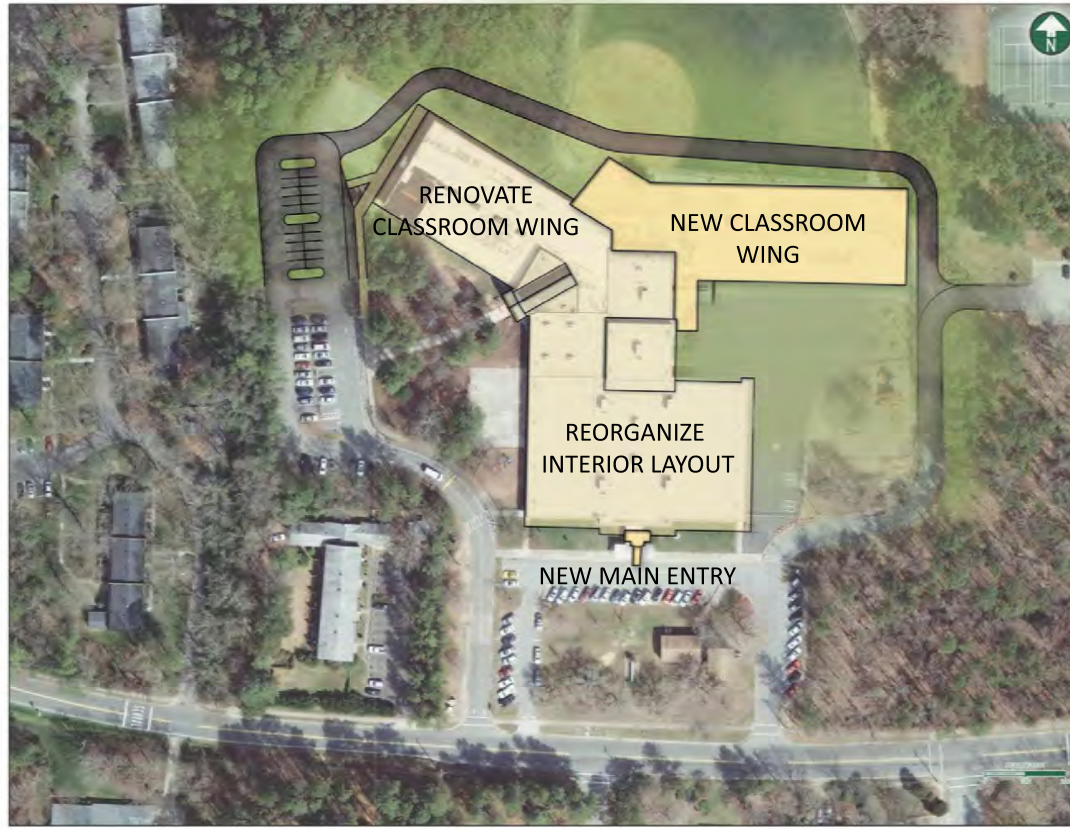
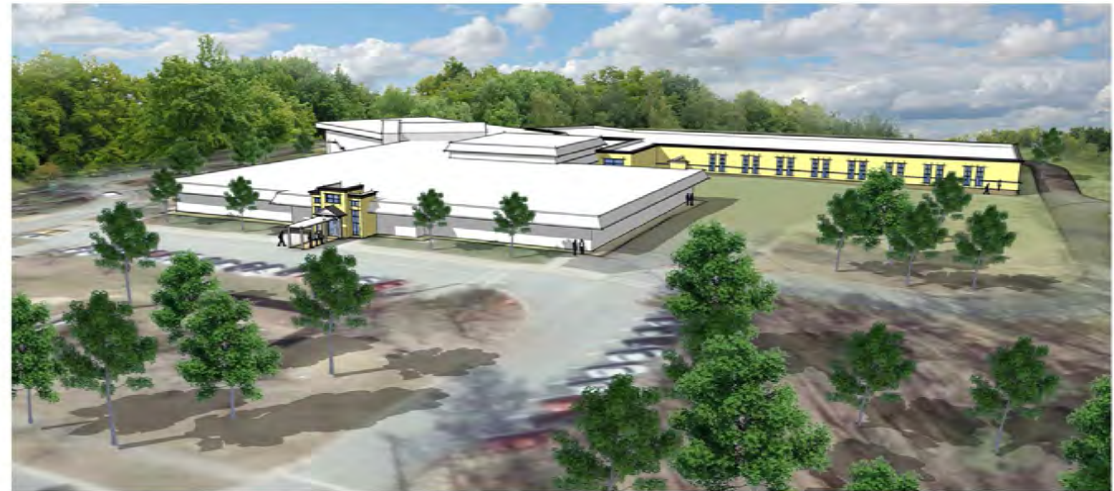
EPHESUS ELEMENTARY SCHOOL

- Seven mobile units on-site housing Pre-K, music, ESL, & administration/guidance offices
- Administration area & cafeteria/kitchen are too small
- Additional classrooms, science project room, music classroom, & administration/staff support spaces are needed
- Main entrance through the atrium does not provide a secure and easily monitored entry point
- Interior layout of existing building is inefficient, many classrooms have no windows
- Aging mechanical system

Construction: Load-bearing CMU wall construction

- Renovate & reorganize the layout of the main building
- Relocate the administration suite to the street front & provide a new secure, main entry
- Provide additional program space to eliminate mobiles & bring school up the space standards
- Increase capacity by 137.

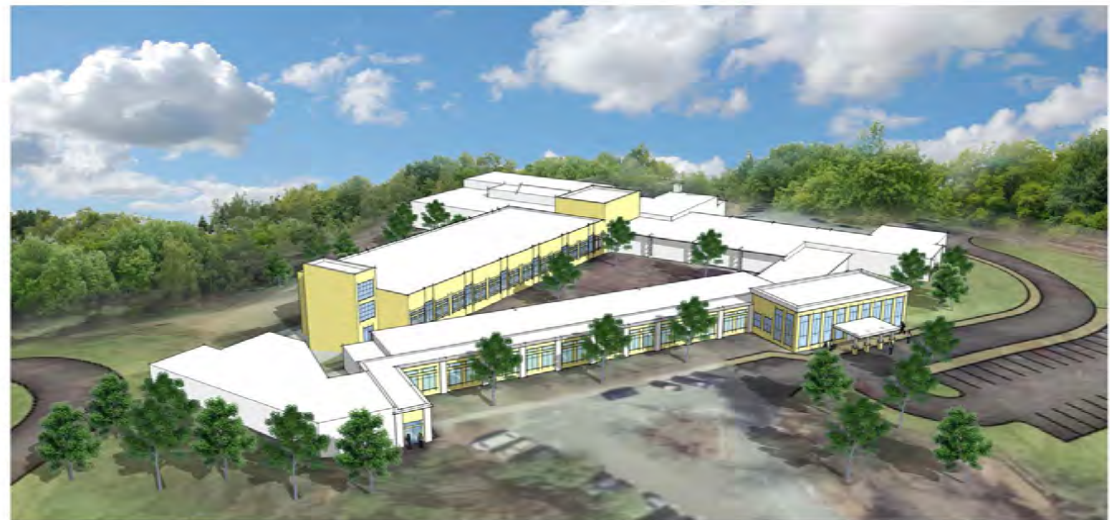
ESTES HILLS ELEMENTARY SCHOOL

- Two mobile units on-site housing Pre-K and a science room
- Most classrooms are 28 to 33% smaller than the current School Construction Standards program
- Program deficiencies, including 4 smaller classroom spaces, administration and staff support spaces
- Classrooms in the 1957 building exit to exterior breezeways and are not secure
- Aging mechanical system
- Queuing forces stacking in the public right of way

Construction: Load-bearing CMU walls with brick veneer & built-up roof over a poured-gypsum deck.

- Provide an administration addition at front to provide necessary staff space as well as a secure main entry
- Classroom wing deconstruction and addition at rear of the school including Pre-K classroom
- Enclose breezeways to connect all classrooms with interior corridors
- Realign the parent drop-off and combine the bus loop with Phillips Middle School to eliminate stacking on Estes Drive
- Connect internally most of the campus
- Eliminate mobile classrooms
- Increase capacity by 58 seats

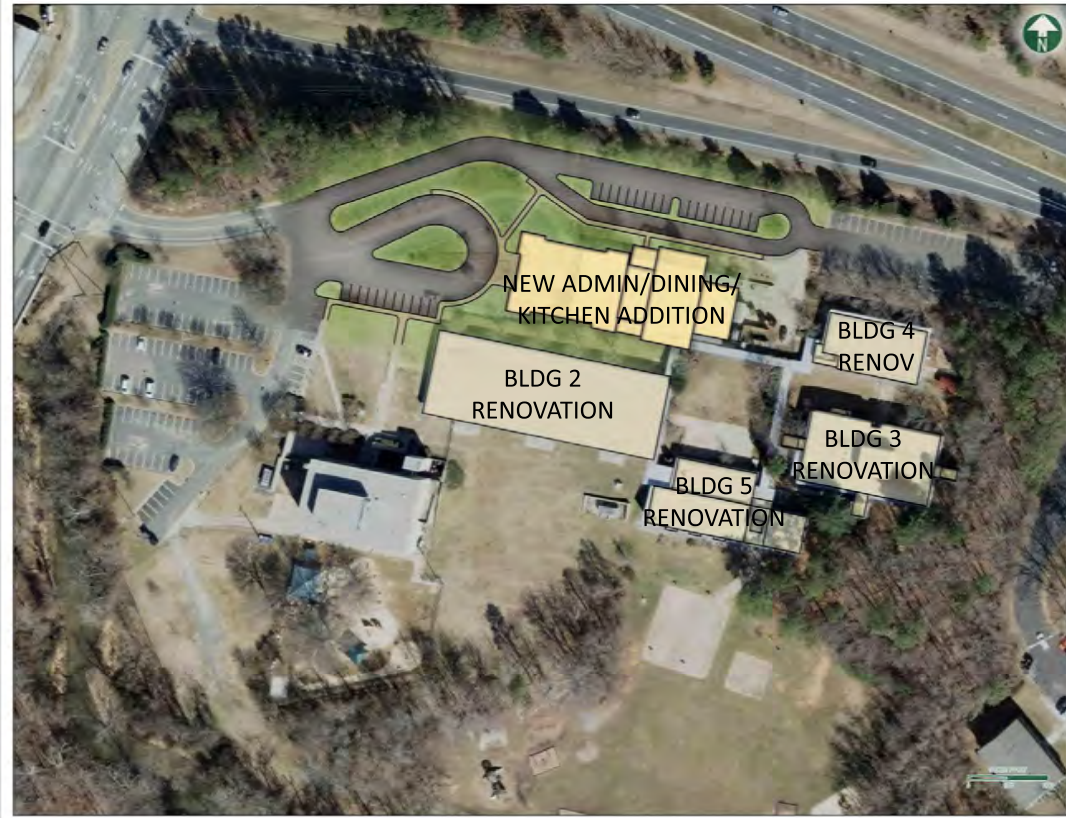
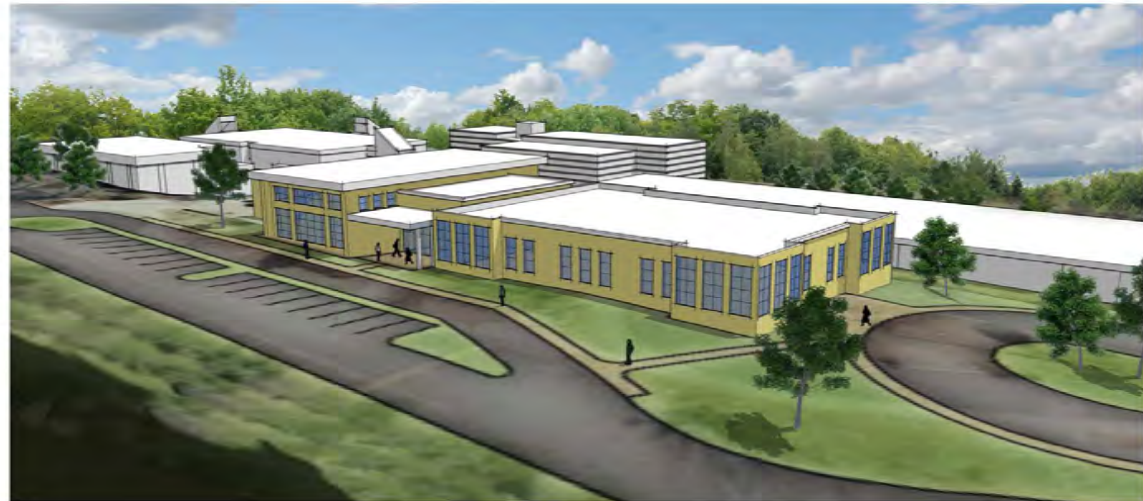
FRANK PORTER GRAHAM ELEMENTARY

- Magnet Spanish dual-language school
- Two mobile units on-site
- Kitchen, dining, & staff support areas are too small
- Existing reception area is in a large open lobby that is not secure
- Water infiltration issues in Building 5
- Campus-style layout
- Aging mechanical system

Construction: Load bearing CMU walls with brick veneer; built-up roof over a poured-gypsum deck & pre-cast exterior wall construction

- Deconstruct existing administration building & construct addition for new administration/dining/kitchen space to meet space standards.
- Provide more prominent front door and secure main entrance
- Renovate existing buildings.

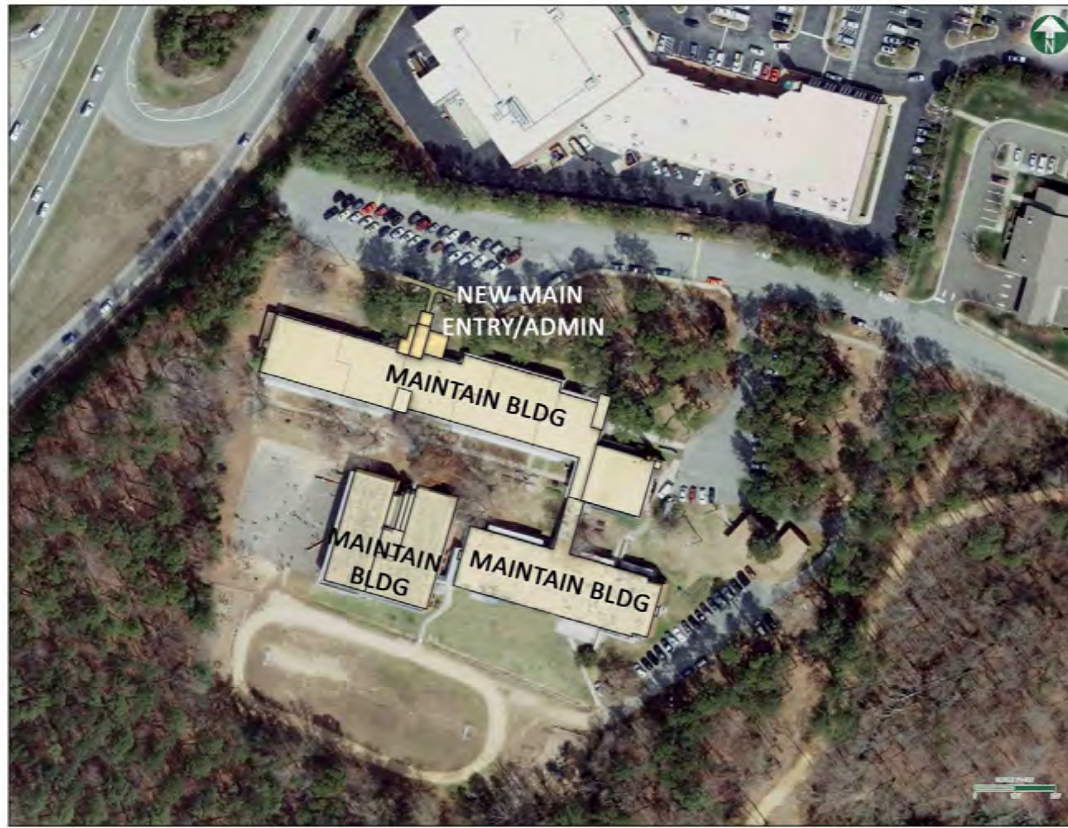
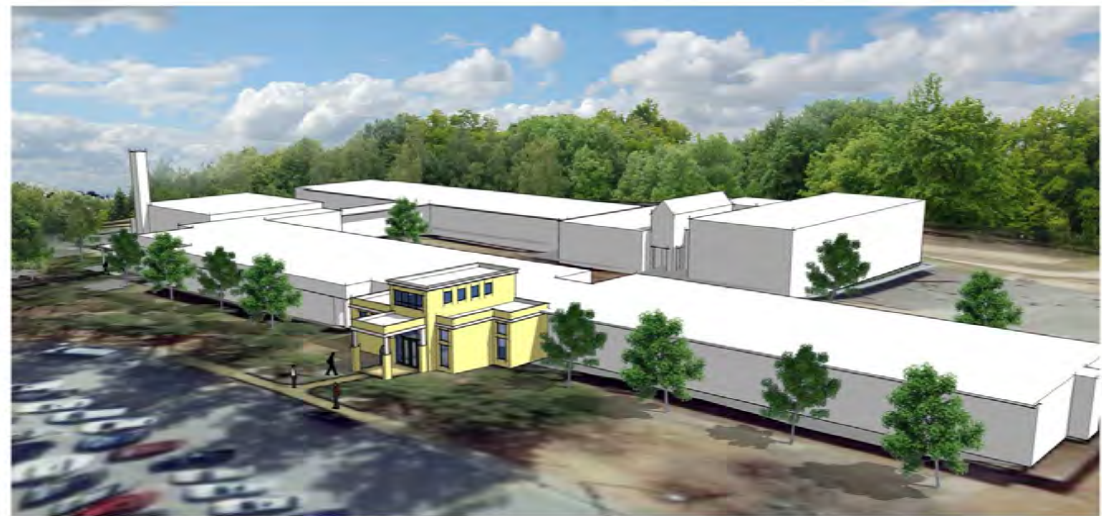
GLENWOOD ELEMENTARY SCHOOL

- Operating over capacity
- Oldest school in the district
- Five mobile units on-site housing 1st & 2nd grade classes
- Basement level rooms are substandard and being used for kindergarten, exceptional education & staff offices
- Administration area, cafeteria, physical education area, media center, & staff support areas are too small
- Existing administration suite is undersized and spread out
- Lack of staff toilet rooms
- Aging mechanical system

Construction: Load-bearing brick in the original building and CMU wall construction in the later additions

- Maintain existing buildings
- Provide small administrative addition and necessary staff space
- Provide secure main entrance

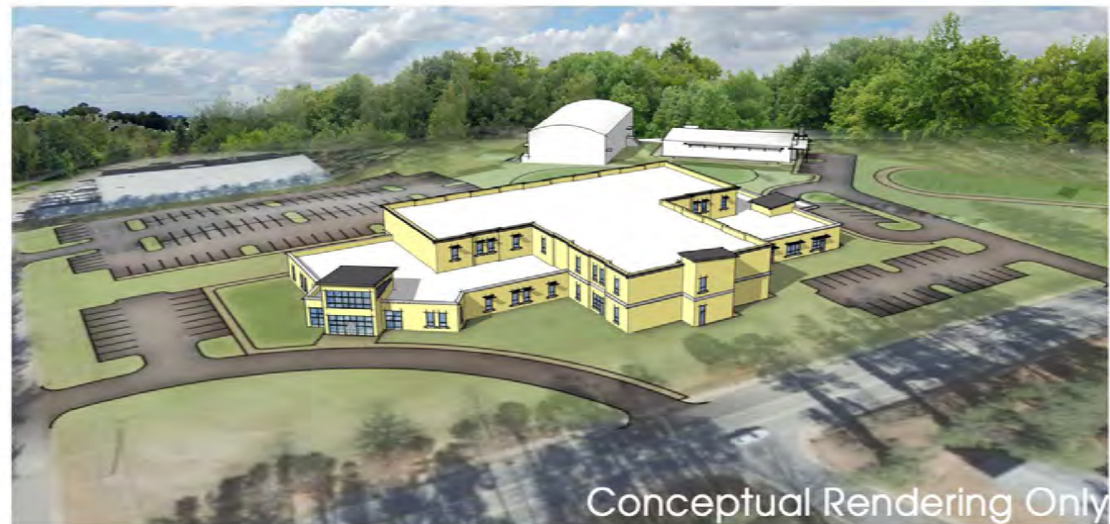
LINCOLN CENTER

- Inefficient layout for departments
- Lack of sufficient space for all central office personnel
- Aging mechanical system creating major humidity issues
- Lack of necessary parking
- Lack of Professional Development space

Construction: Load-bearing CMU walls

- Deconstruct the existing Lincoln Center building. Gymnasium, Phoenix Academy, & maintenance building to remain
- Construct a building to house both Pre-K program & new central office
- Increase elementary capacity by 189
- Work with Community to preserve historic aspects of building and site

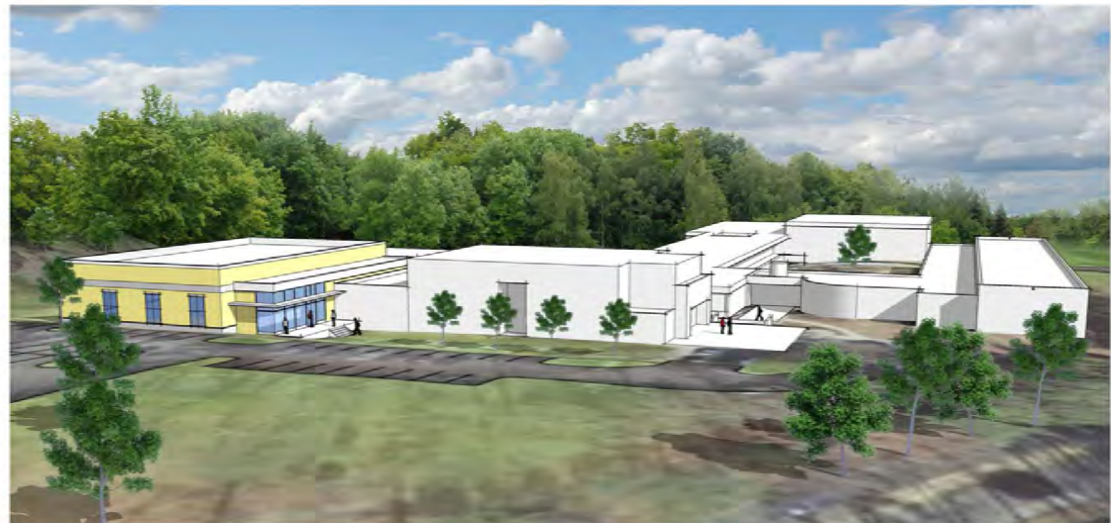
PHILLIPS MIDDLE SCHOOL

- No mobile units
- Art education & music spaces and a foreign language classroom are deficient
- Existing main entrance is not secure
- Major water infiltration issues in the basement
- Aging mechanical system

Construction: Steel frame construction with brick veneer exterior walls and load bearing masonry walls at the gymnasium and concrete retaining walls at the lower level

- Renovate existing building
- Provide additional program space to meet space standards, including increasing the administrative suite to provide a secure main entry
- Provide new queuing configuration

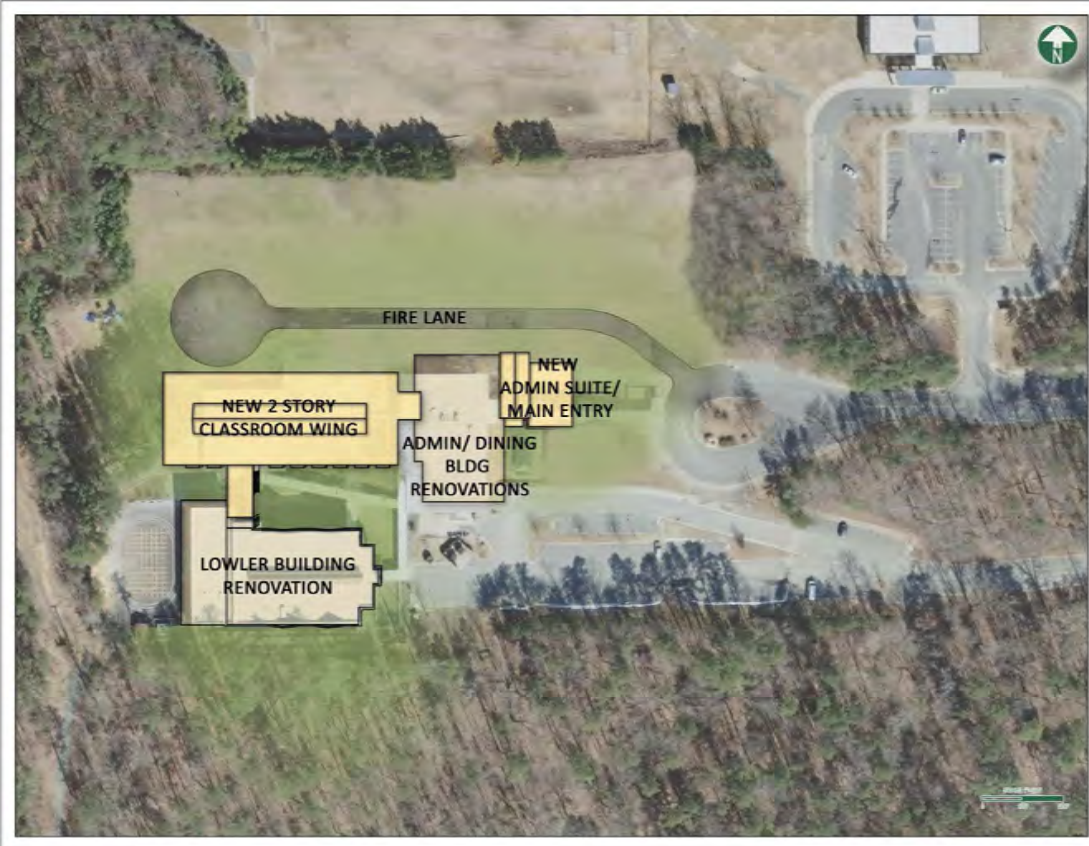
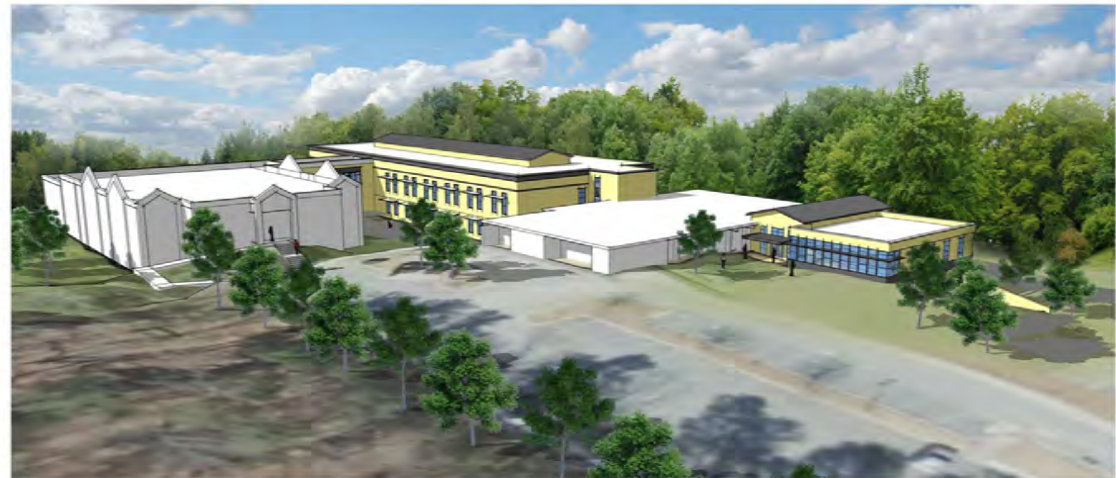
SEAWELL ELEMENTARY SCHOOL

- Operating over capacity
- Six mobile units on-site housing classroom space
- Administration area, physical education area & staff support areas are too small
- Media center support spaces are lacking
- Lack of storage rooms
- Aging mechanical system
- Campus-style layout with classrooms exiting to the exterior
- Aging kitchen equipment
- Exterior structural remediation needed at one of the classroom pods

Construction: Load bearing brick construction appears to be the main structural system for the original building and load bearing CMU and steel frame construction for the 1989 addition

- Deconstruct the five classroom pods.
- Renovate the existing administration/dining building & Lowler Building.
- Eliminate use of mobiles as classrooms
- Provide additional program space to meet space standards & replace deconstructed classrooms (do not increase kitchen).
- Increase capacity by 119.
